# Contamination Screening Evaluation Report

This report develops, evaluates and compares the Build Alternatives for the Project Development and Environmental Study of SR 87 Connector Project from US 90 to SR 87 N in Milton.

# Santa Rosa County Florida

August 9, 2013

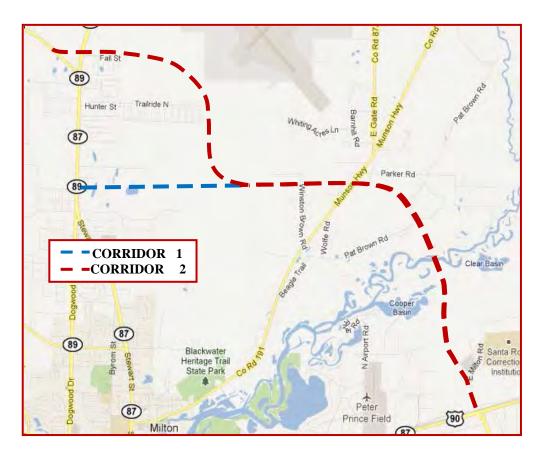
Figure 3A: Map of Two Remaining Corridors

Corridors 1 and 2 remain as the focus of the SR 87 Connector PD&E Study. Both of these alternative corridors begin at the SR 87 and US 90 intersection and head north over Blackwater River. Each of the alternative corridors then makes a westward turn towards SR 87 North, remaining south of Whiting Field Naval Air Station. Corridor 1 continues due west, connecting to SR 87 at Oakland Drive. Corridor 2 makes a northward turn before finally heading back west to intersect with SR 87 at Season Drive. A map showing the two remaining alternative corridors is included as *Figure 3A*. A detail map of the two remaining corridor ending points is included as *Figure 3B*.

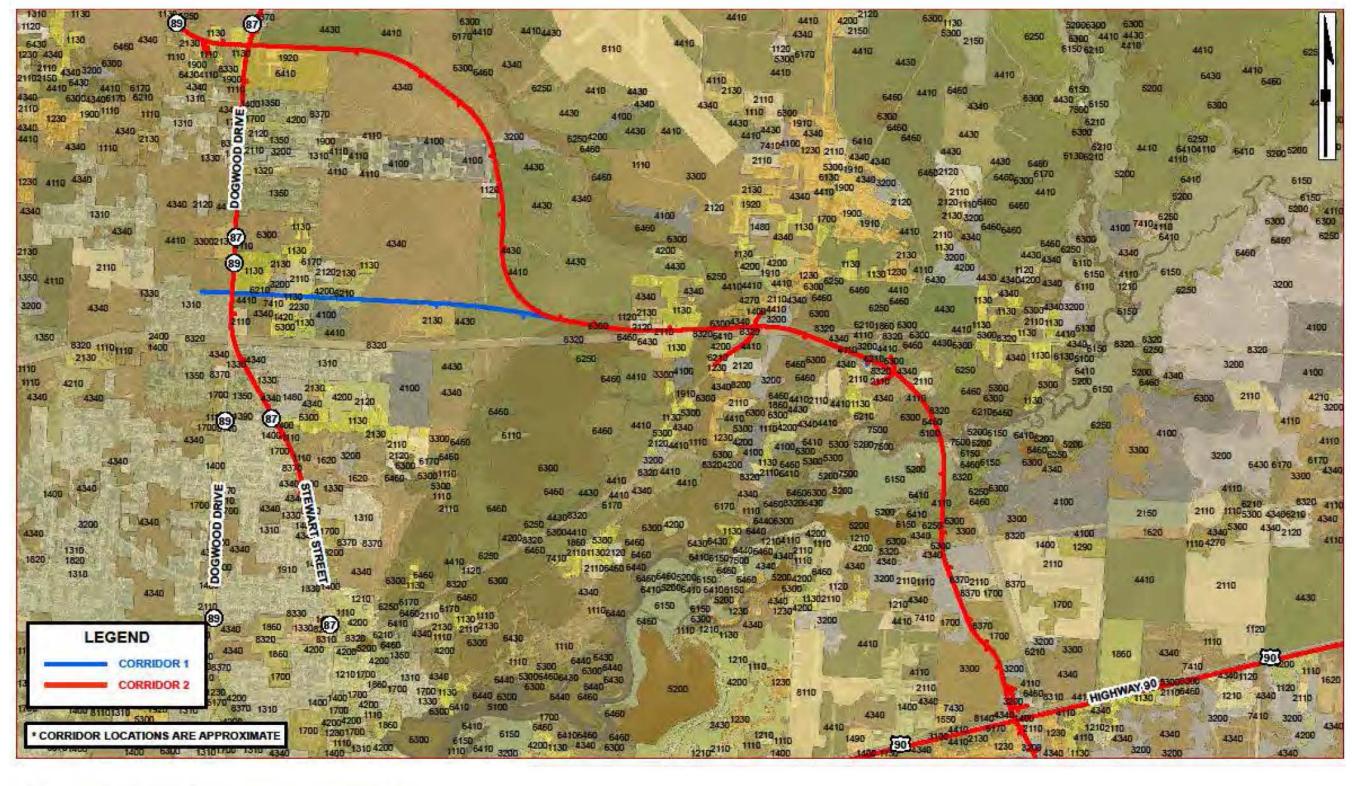
Figure 4A: 2004 FLUCCS Land Use Map

The 2004 Florida Land Use, Land Cover Classification System (**FLUCCS**) Land Use Map was reviewed to identify the various land uses found within and adjacent to the SR 87 Connector alternative corridors as well as the areas containing the majority of the potential contamination sources.

Due to the length of the alternative corridors, a wide variety of existing land uses were identified during the map review. The beginning and ends of both Corridor 1 and Corridor 2 are located in predominately developed areas and therefore contain land uses commonly identified in populated areas. In general, land uses found near the SR 87/US 90 and SR 87/SR 89 intersections consists of land uses similar to, but not limited to, Commercial and Services (FLUCCS 1400) and Mixed Unit Residential (FLUCCS 1230), as well as Shrub and Brushland (FLUCCS 3200) and Mixed Rangeland (FLUCCS 3300).

The interior portion of the alternative corridors traverses lands that are largely undeveloped. As a result, the land uses identified along the corridor interiors are those typically associated with rural areas. In general, land uses typically found on the corridors' interior include, but are not limited to, Mixed Rangeland (FLUCCS 3300), Shrub and Brushland (FLUCCS 3200), Wetland Forested Mixed (FLUCCS 6300), Hardwood-Coniferous Mixed (FLUCCS 4340), and Forest Regeneration Areas (FLUCCS 4430). The 2004 FLUCCS Land Use Map has been included as *Figures 4A* and *4B* and includes the complete identification of land uses within the project vicinity.

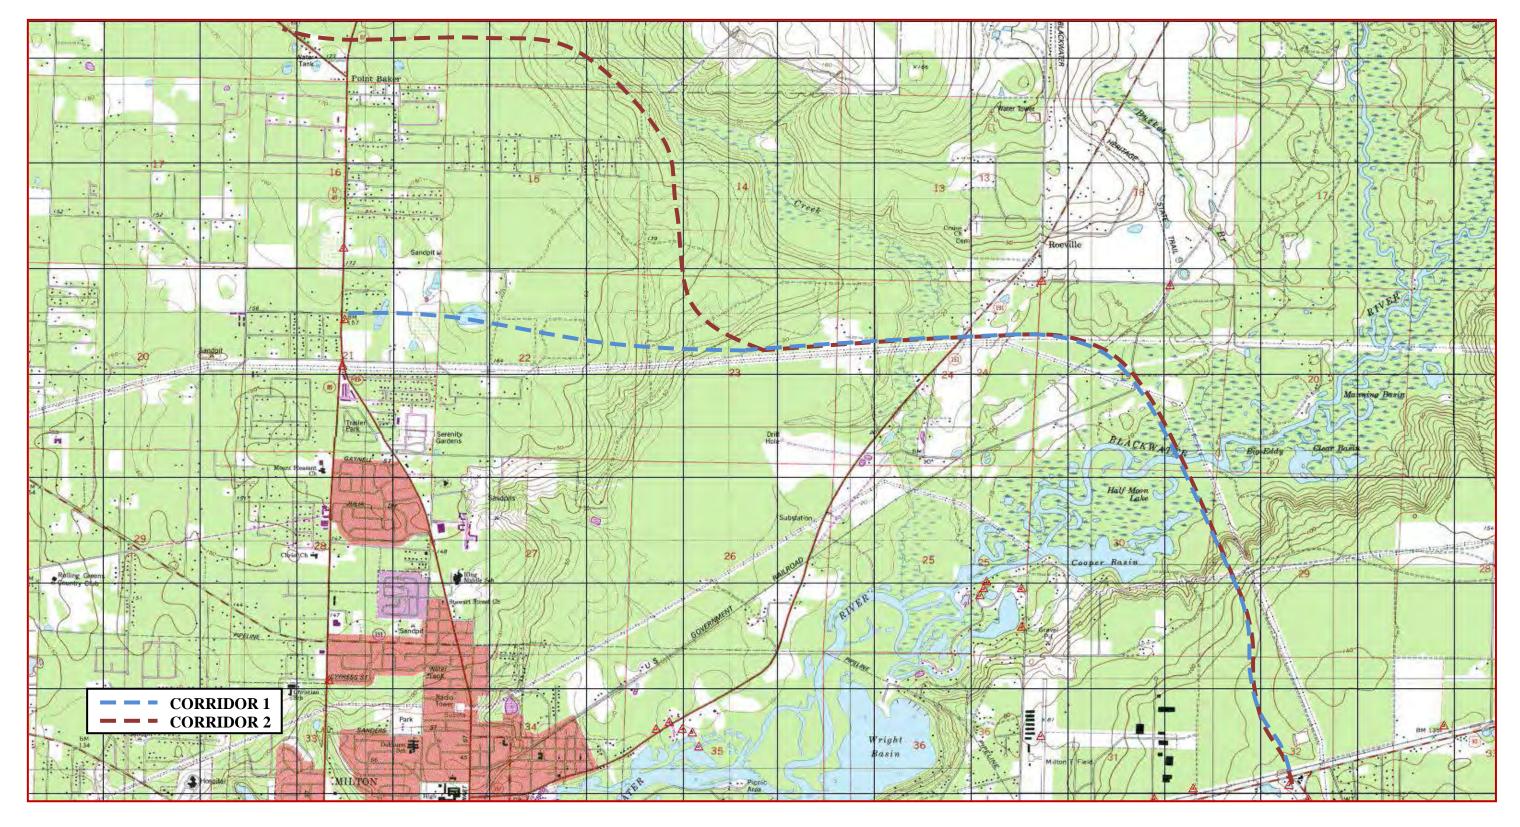
Figure 5: USGS Topographic Map

The dominating topographic features found in this region are those associated with the side slopes of the Blackwater River and Clear Creek lowlands. There is a steep descent on the south bank of the Blackwater River that contains significant grade changes from higher elevations to lower elevations when moving toward the river. The western portion of the project area also contains significant elevation changes that likely channel surface water east towards Clear Creek and Blackwater River.

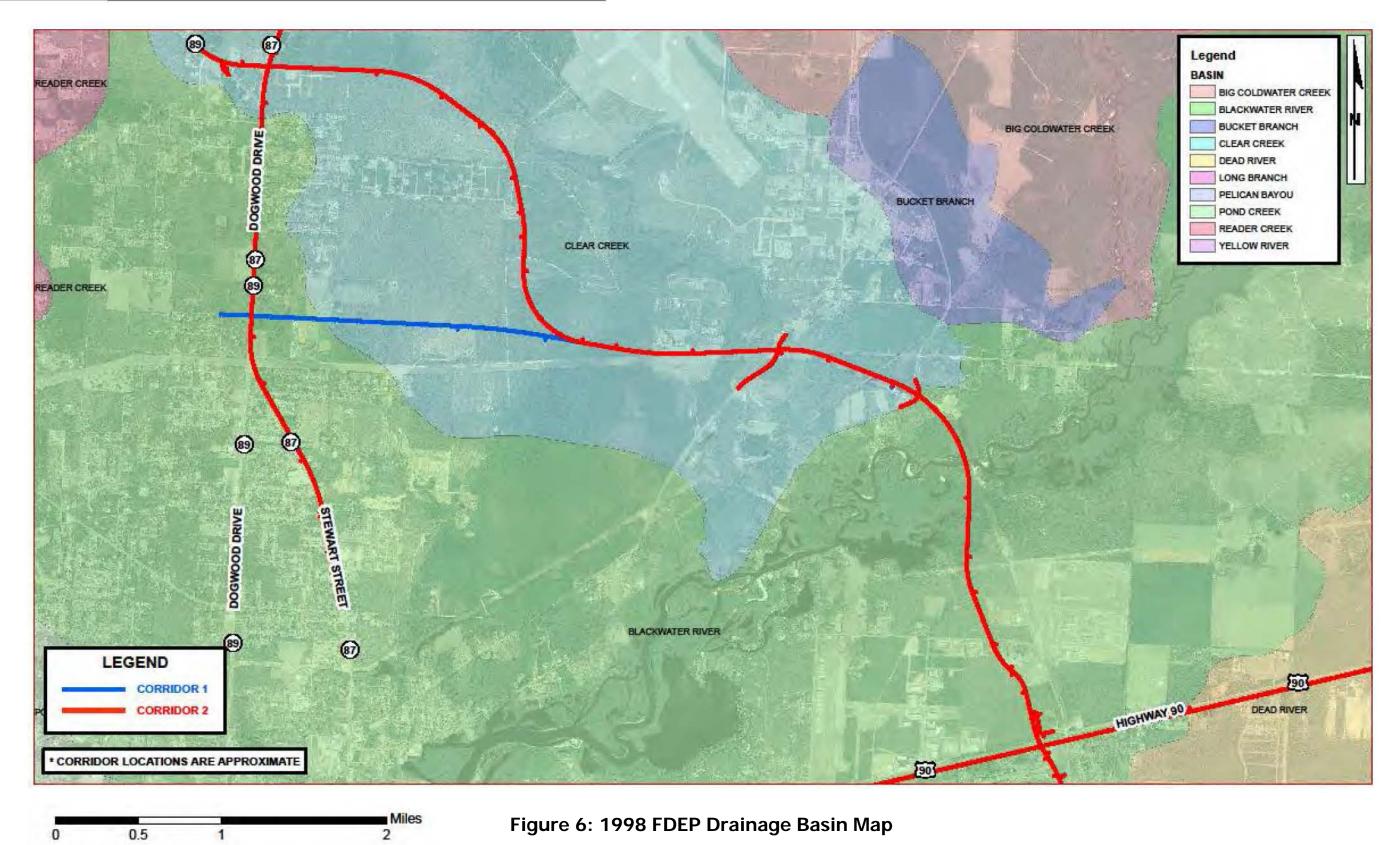
A review of the FDEP 1998 Drainage Basin map reveals that the alternative corridors pass through two main drainage basins: the Blackwater River basin and the Clear Creek basin. The Clear Creek basin occupies much of the land north of the Blackwater River. Clear Creek flows from north to south and eventually empties into the Blackwater River. The Blackwater River basin is found south of the Clear Creek Basin and extends to the south of US 90 and Milton, and to the west of SR 87 and SR 89. The 1998 FDEP Drainage Basin Map and legend has been included as *Figure 6*.

Considering the general directional movement of surface water in the area as well as the permeability characteristics of the sand-and-gravel aquifer, it is reasonable to expect directional migration of potential contamination to generally coincide with surface water movement. Localized surface water and ground water directionality can vary over short distances, but it should be anticipated that surface water and ground water found in the sand-and-gravel aquifer will generally move from upper elevations to lower elevations, thus, possible contamination migration may also be anticipated to move down gradient towards Blackwater River or Clear Creek.

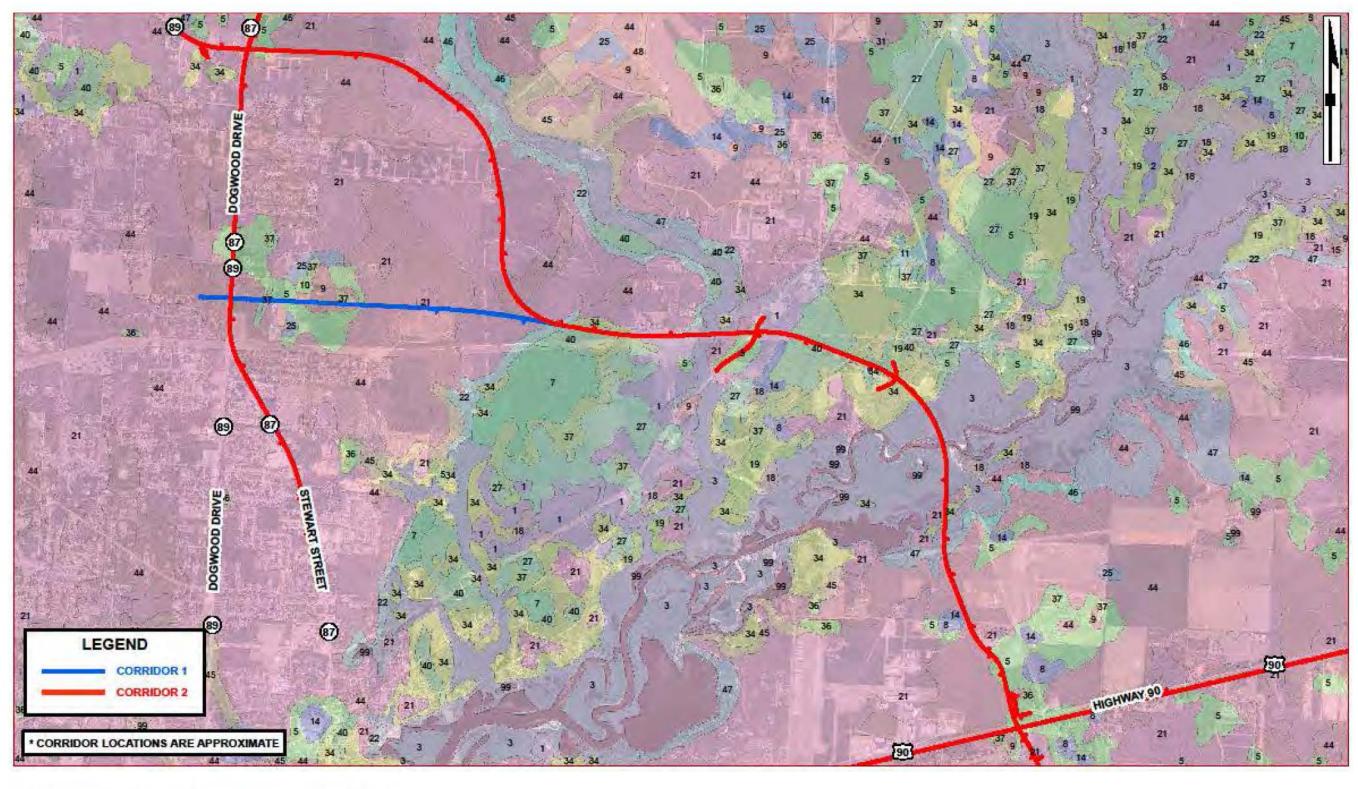
Figure 8A: USDA Soil Survey Map

A review of the United States Department of Agriculture's (USDA) Soil Survey for Santa Rosa County was conducted to evaluate the flow characteristics and subsurface conditions as they relate to potential migration of contamination. Following are descriptions of soil types that constitute a *majority* of the lands occupied by the alternative corridors. However, the following descriptions are not an exhaustive list and field encounters with other material types should be expected. The entire USDA Soil Survey and legend for the project area have been included as *Figures 8A and 8B* respectively.

Lakeland Sand is an excessively drained, nearly level soil found on broad ridgetops in upland areas. The surface layer is typically dark grayish brown sand about 4-inches thick followed by yellowish brown, grayish brown, and brownish yellow sand layers to a depth of 80-inches or more. The water table is usually at a depth of more than 72-inches and permeability is very rapid in Lakeland Sand.

This well drained soil is also found on nearly level ridgetops in upland areas. Layers of dark grayish brown, yellowish brown, and yellowish red loamy sand and sandy loam are found to depths of more than 80-inches. The water table in Troup soil is usually greater than 6-feet and permeability is rapid throughout.

The Bibb-Kinston Association is a poorly drained soil found in drainageways and on floodplains along streams and rivers. The Bibb soil commonly has a surface layer of very dark gray silt loam about 6-inches thick. The subsurface layer is dark gray silt loam about 11-inches thick. The subsoil layers consist of gray silt loam followed by brownish gray and yellowish brown fine sand to a depth of 65-inches or more. Permeability is moderate in these soil types, and the water table is usually at a depth of 10-inches or less for 6 months or more during most years.

This moderately well drained to somewhat poorly drained soil is often found on low positions in the uplands. Very dark gray, grayish brown, and yellowish brown loamy sand make up this soil type to depths of 80-inches or more. Permeability is usually

The review indicated numerous soil types in the lowland floodplains associated with Blackwater River and Clear Creek. Therefore, the preceding material descriptions should not be taken as a complete listing of soil types found within the project limits, but rather a generalization of similar soils that may exist within Corridors 1 and 2 of the SR 87 Connector.

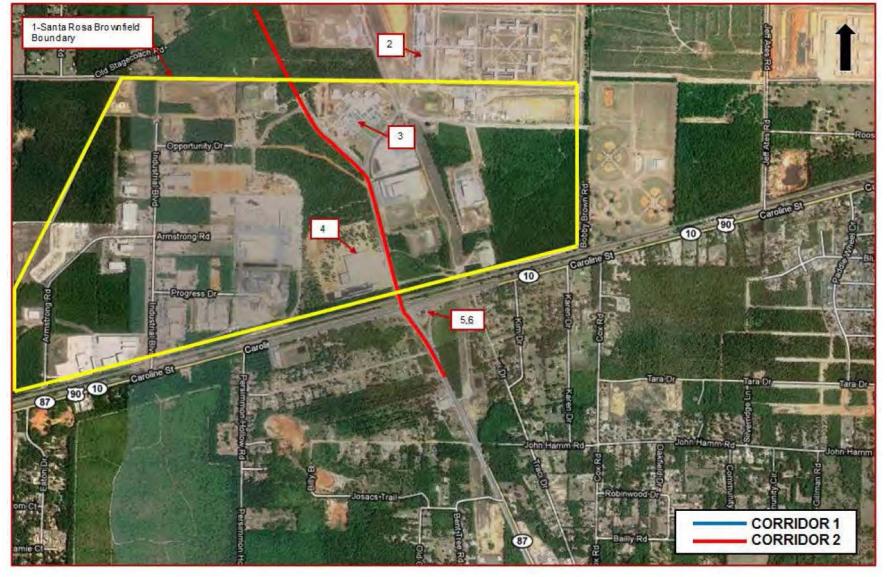
Figure 9: Aerial Photograph of Potential Contaminated Sites 1-6 (South Intersection)

A total of twelve (12) sites were identified as being potential sources of contamination to at least one of the two alternative corridors for the SR 87 Connector. The sites are concentrated around the beginning and ending points of the proposed alternative corridors. Sites 1-6 are found in the southeast portion of the project limits near the SR 87/US 90 intersection and Sites 7-12 are found in the northwest portion of the project limits near the SR 87 (Stewart Street) and SR 89 (Dogwood Drive) intersection.

Three (3) locations within the Brownfield limits were identified as potential sources of contamination. Though the source and severity of the potential contamination varies from site to site, the locations identified within the Santa Rosa Brownfield Redevelopment Area have all been assigned a ranking of **MEDIUM** for potential environmental impact. Below is a listing of the locations found within the Brownfield limits and the database in which they were identified as a potential contamination source:

• **Site 2:** Santa Rosa Correctional Institute; Aboveground Storage Tank (AST), Hazardous Waste Generator (RCRIS)

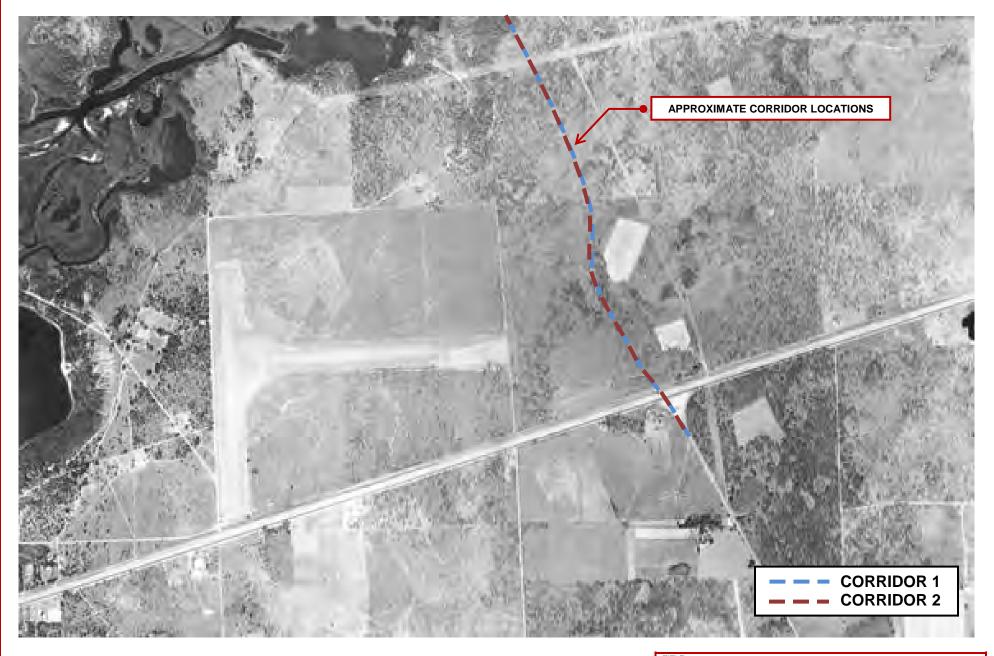
1955 HISTORICAL AERIAL
SR 87 CONNECTOR PD&E STUDY
CONTAMINATION REPORT
SANTA ROSA COUNTY, FLORIDA

Historical aerial photographs from 1940, 1955, 1978 and 1992 were reviewed to determine the historic land use of Corridors 1 and 2. These photographs were also used to identify visible activities or businesses on or adjacent to the segments that would likely have used and/or stored hazardous materials. Copies of the historical aerial photographs have been included as *Appendix A*. A brief description of the historical aerial review follows:

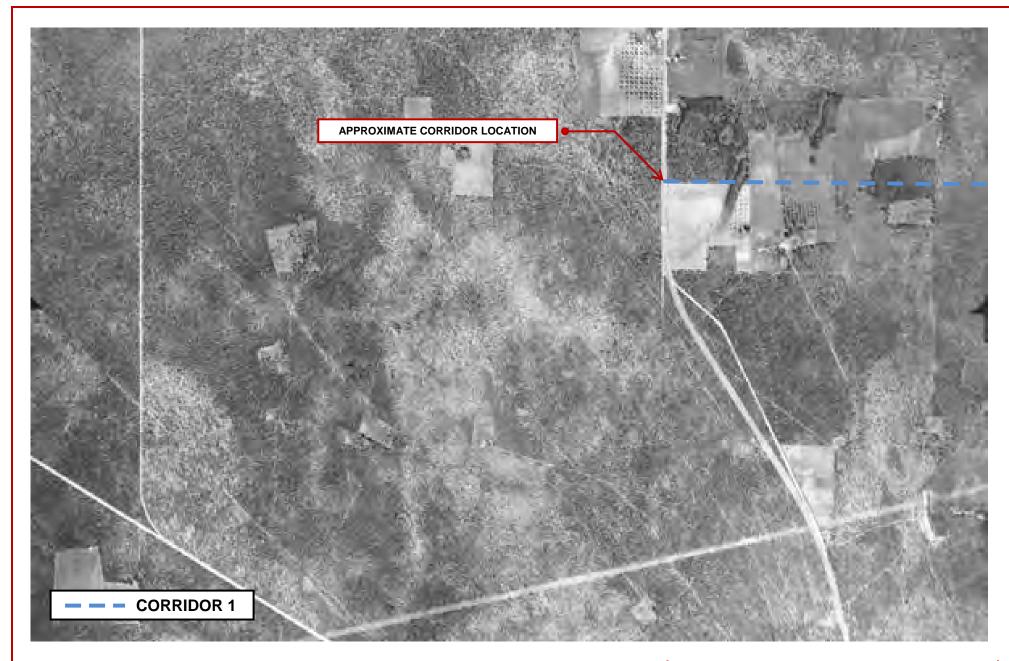
NORTH BOUNDARY
CORRIDOR 1
SR 87/OAKLAND DRIVE INTERSECTION

1940 HISTORICAL AERIAL SR 87 CONNECTOR PD&E STUDY CONTAMINATION REPORT SANTA ROSA COUNTY, FLORIDA

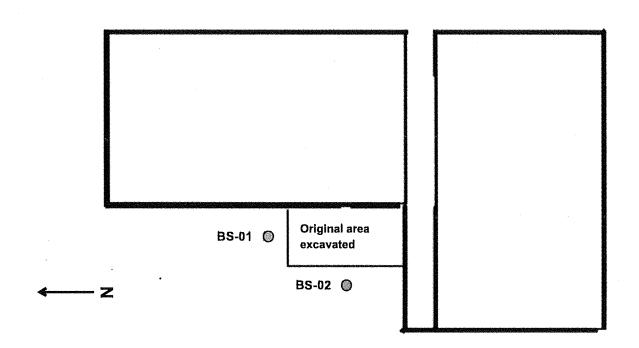
Figure 1 - Sample Location Map September 2009 and February 2010 Delineation Samples Faulkner Property, Milton, Florida

#### **SAMPLNG AREAS**

BS-01 North side of original excavation area BS-02 West side of original excavation area

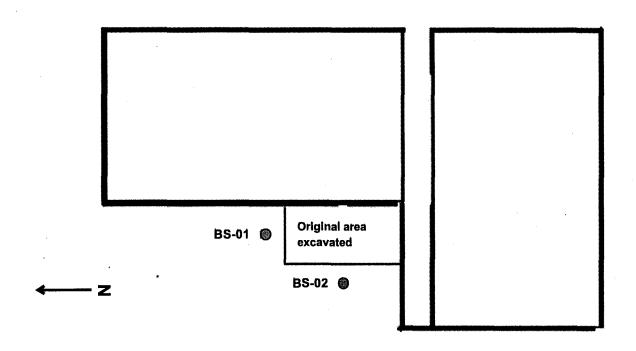
Figure 1 - Sample Location Map September 2009 and February 2010 Delineation Samples Faulkner Property, Milton, Florida

#### **SAMPLNG AREAS**

BS-01 North side of original excavation area BS-02 West side of original excavation area
